Flash report on the damage of Mexico City and Puebla related to the 2017 Puebla-Morelos Earthquake

National Research Institute for Earth Science and Disaster Resilience (NIED) Tsuneo Ohsumi and Yuji Dohi

Motivation

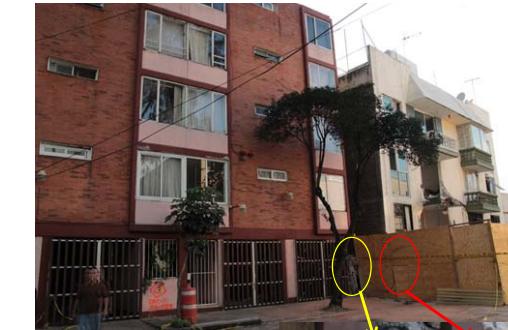
Two adjacent houses were built in the same period in 1970. Both buildings will be demolished. However, the building on the right was heavily damaged and the parking lot on the first floor was collapsed. Inspecting at the column parts, on the left side housing, the building's column used construction method for the hoops/stirrups as 45 cm pitch. On the right side housing, the hoops/stirrups were very poor. The quality of the concrete is also considered to be better in the building on the left side.

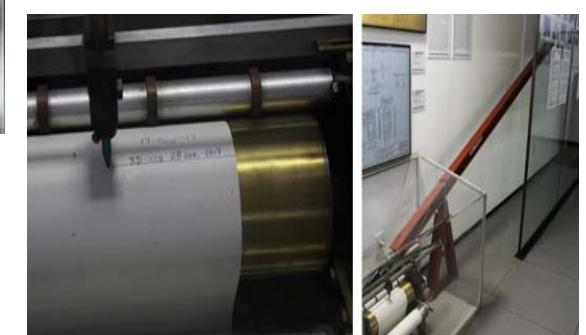
Deform meter of the Latin American tower.
(photo taken by T. Ohsumi at November 21, 2017)
