台湾と日本の斜面崩壊発生に関する比較

防災科学技術研究所マルチハザード評価研究部門
陳 麒文

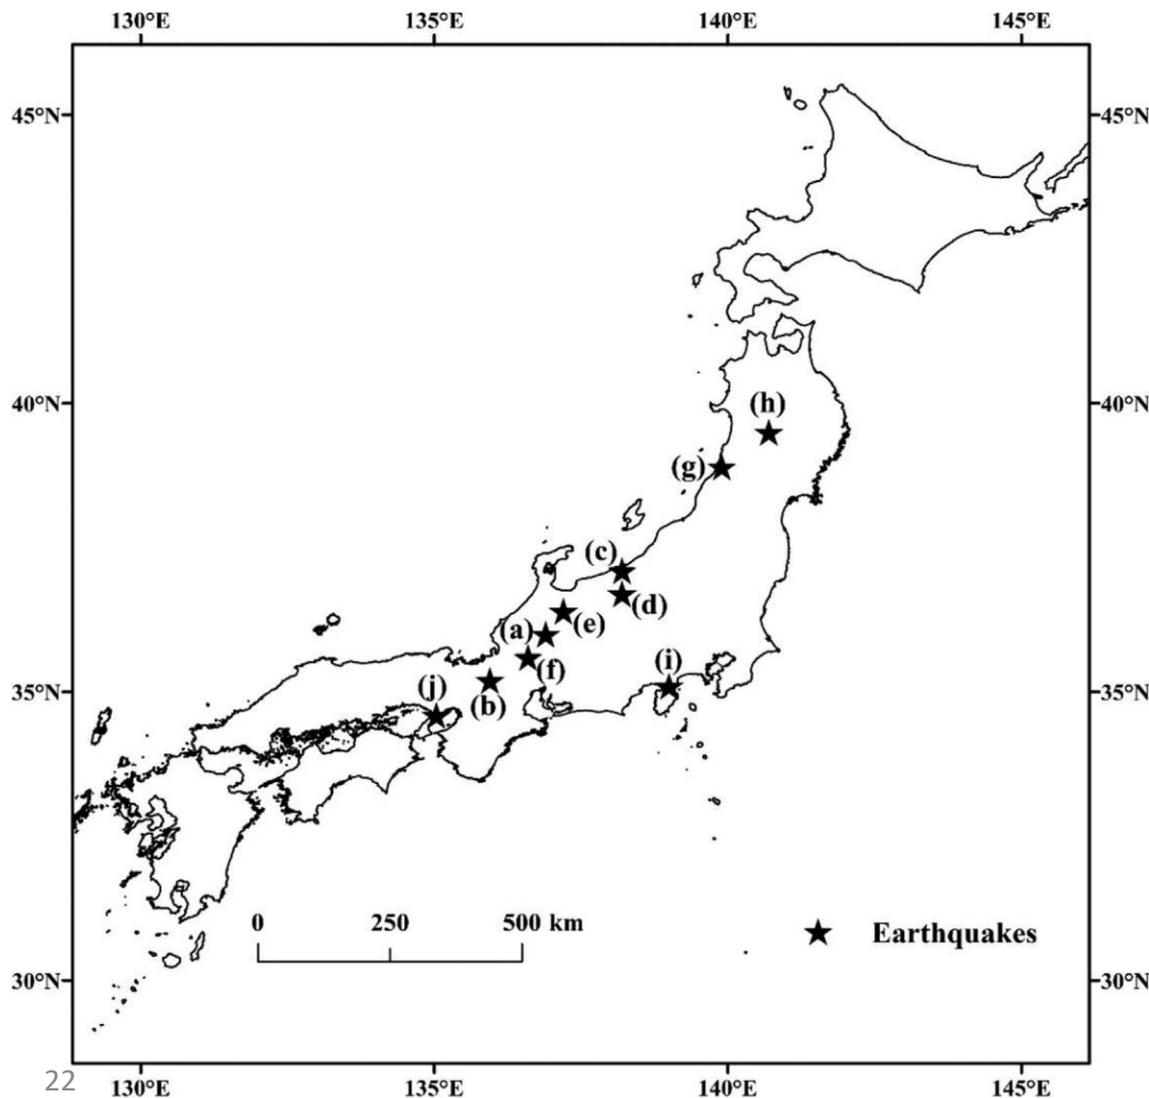
大地震と深層崩壊 (1586 - 1995)

- (a) 1586 天正地震
- (b) 1662 近江若狭地震
- (c) 1751 高田地震
- (d) 1874 善光寺地震
- (e) 1858 飛越地震
- (f) 1891 濃尾地震
- (g) 1894 庄内地震
- (h) 1896 陸羽地震
- (i) 1930 北伊豆地震
- (j) 1995 兵庫県南部地震

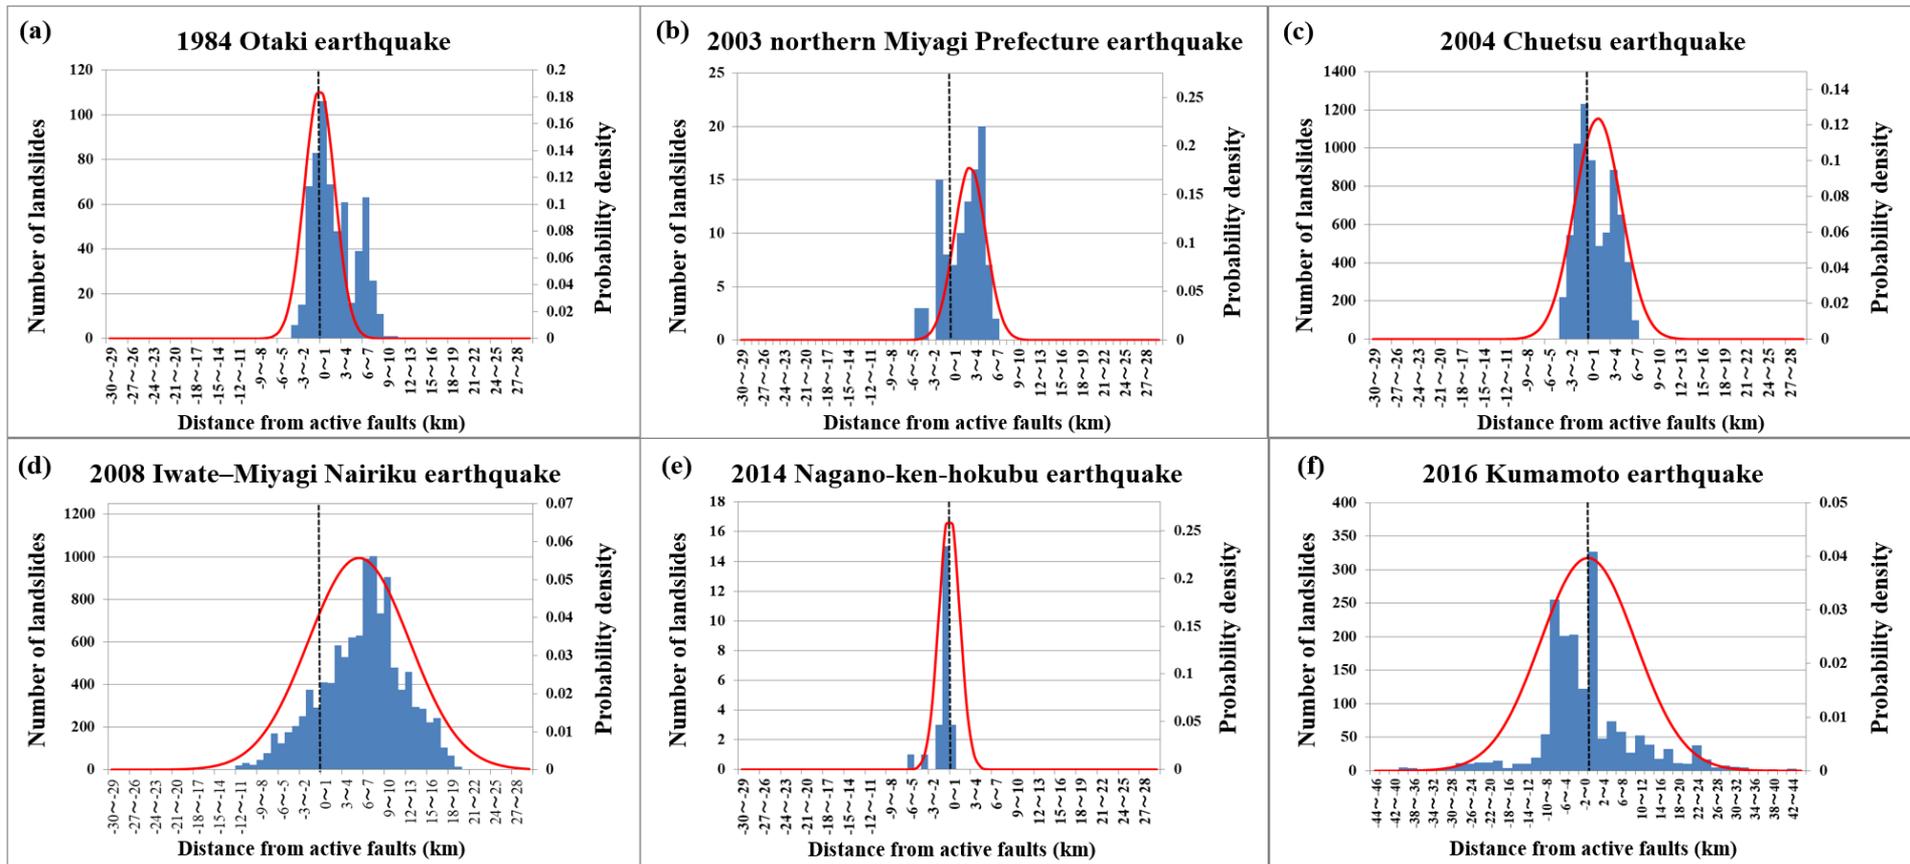
斜面崩壊分布 (正規分布)

Normal distribution

$$f(x) = \frac{1}{\sqrt{2\pi}\sigma} \exp\left(-\frac{(x - \mu)^2}{2\sigma^2}\right)$$

$$\begin{cases} \mu = -0.188 \times I + 11.280 & (I \leq 60^\circ) \\ \mu = 0 & (I > 60^\circ) \end{cases}$$

$$\sigma = 0.472 \times D + 1.701 \times 10^{-15} \times E + 0.202$$

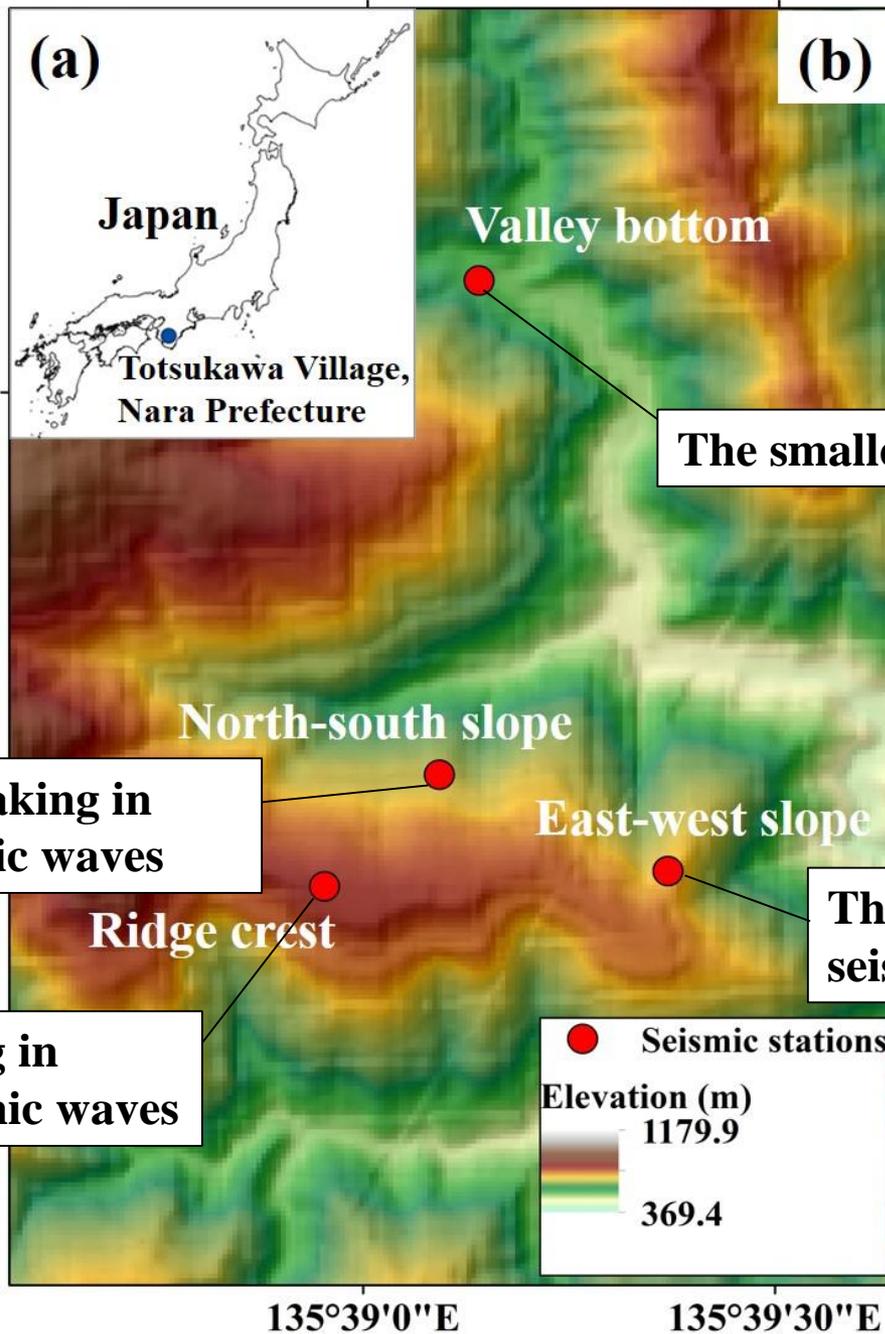
The smallest ground shaking

The largest ground shaking in lower-frequency seismic waves

The largest ground shaking in seismic waves with >10 Hz

Large ground shaking in lower-frequency seismic waves

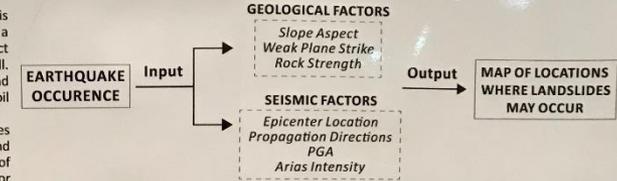
Figure 1: Analysis procedure for distribution and probability of earthquake-triggered landslides.

The focus of this study is on studying factors of earthquake-triggered landslides. After an earthquake occurs, both seismic and geological factors which may influence distribution and probability of landslides should be taken into consideration. The idea of the analysis procedure is as follows (Fig. 1):

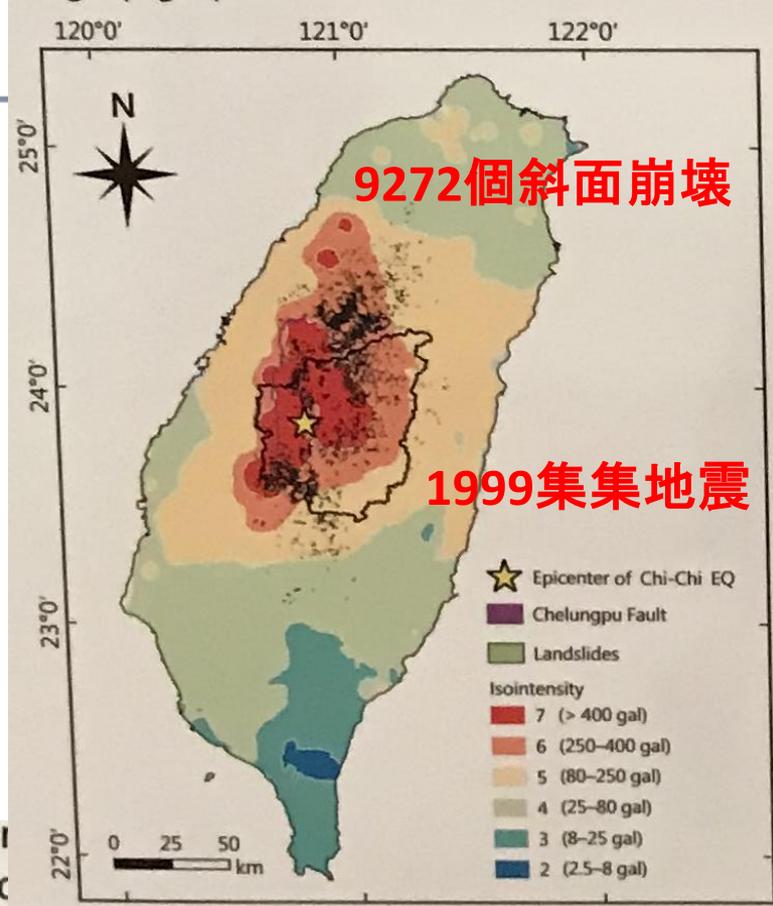
- 半数以上の崩壊は斜面方位と地震波方向の夾角 $< 90^\circ$

About 52.6% of the landslides have the angles of smaller than 90° between their hillslope aspects and the propagation directions of the seismic waves of the 1999 Chi-Chi earthquake. Each of the angle groups have similar numbers of the landslides.

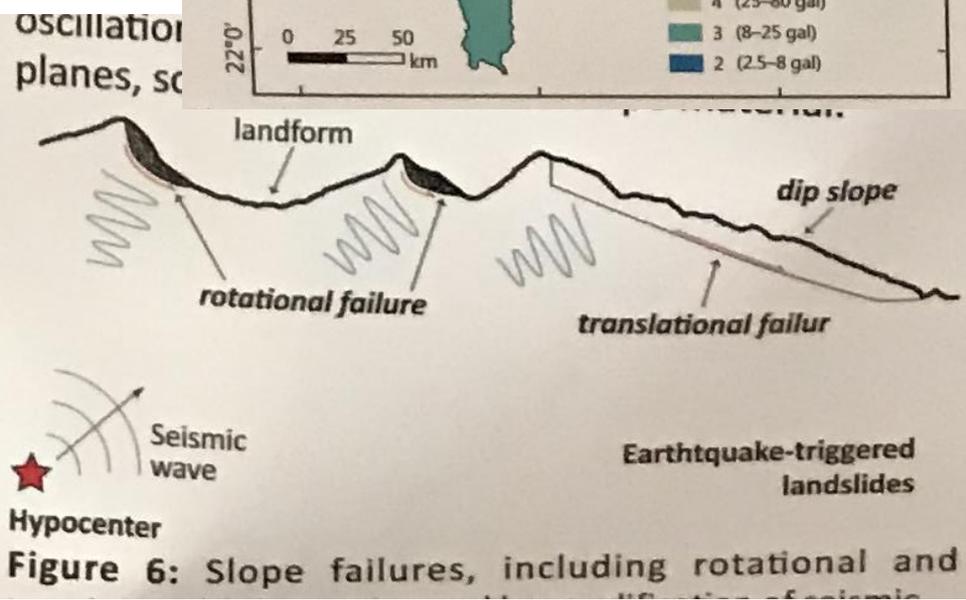
Figure 6: Slope failures, including rotational and translational failures, triggered by seismic waves.

When seismic waves coming from a hypocenter reach the hillslopes whose aspects are parallel to the propagation direction, the wave amplitude can be amplified probably owing to unconsolidated material near the ground surface, or due to wave oscillation parallel to the hillslope surfaces or weak planes, so that destabilize the slope material.
