Flash report on the damage of Mexico City and Puebla related to the 2017 Puebla-Morelos Earthquake

National Research Institute for Earth Science and Disaster Resilience (NIED) Tsuneo Ohsumi and Yuji Dohi

Motivation

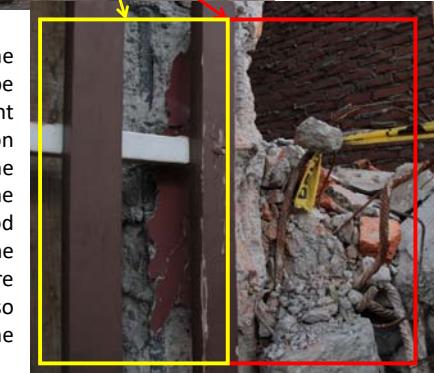
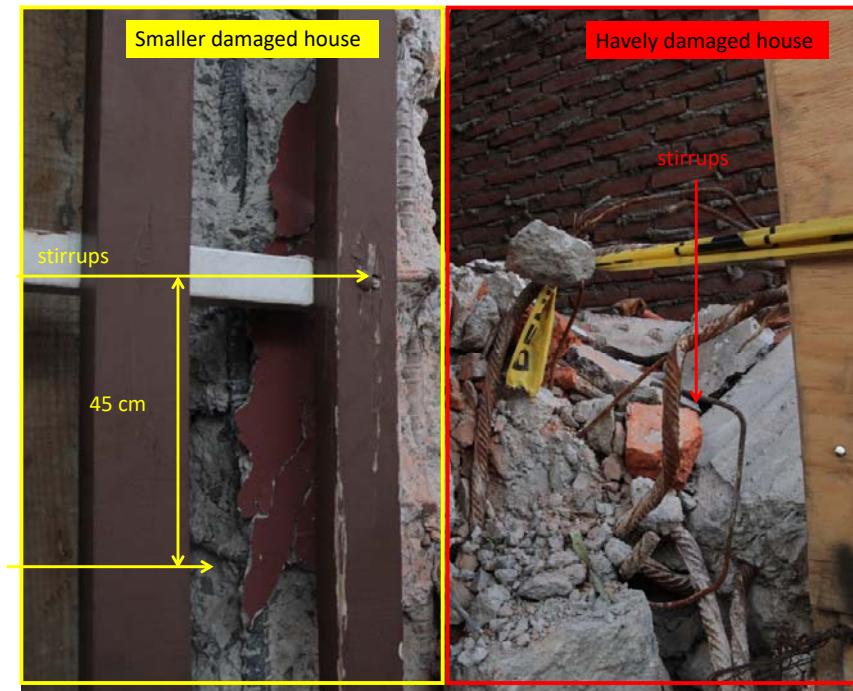
Two adjacent houses were built in the same period in 1970. Both buildings will be demolished. However, the building on the right was heavily damaged and the parking lot on the first floor was collapsed. Inspecting at the column parts, on the left side housing, the building's column used construction method for the hoops/stirrups as 45 cm pitch. On the right side housing, the hoops/stirrups were very poor. The quality of the concrete is also considered to be better in the building on the left side.

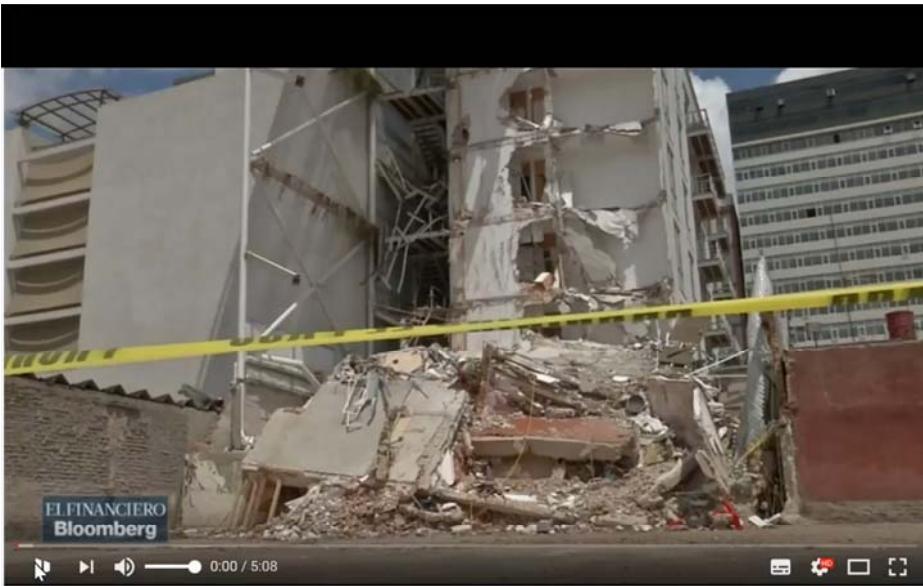
Edificio en Zapata 56 podría haberse derrumbado, incluso sin el sismo
